The summer sailing season is here and if you haven't done it already, it's time to check your rig. Riggtech owner, **Phill Bate**, a former America's Cup sailor explains how to check your standing rigging and what to look for.

Inspecting your

The right way!

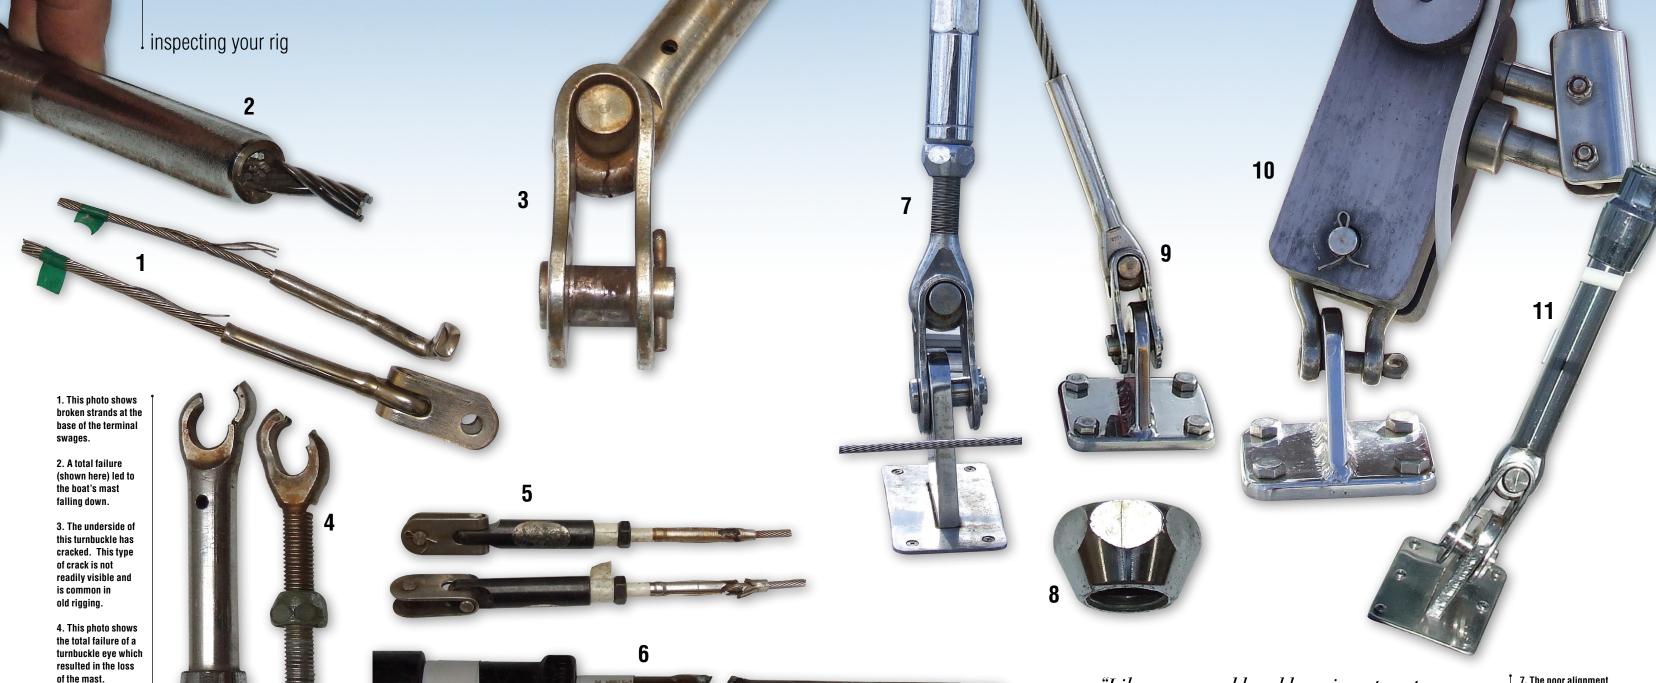
hold the swages with a shifting spanner, they failed. around the 7 year mark as I have seen many failures from this point on, and 6. Here is an sometimes beforehand. There are sevexample of the total eral reasons for this which are outlined failure of a stainless

5. Here is an

example of failure

terminal due to

corrosion.

due to corrosion.

Terminal swages should also be checked along the length of the swaged area as it is quite common to see longitudinal and transverse cracks here. This type of cracking can be caused by work hardening of the material in an incorrect swaging process! Long term corrosion inside the swage socket is the other major factor for this kind of failure (see photos 5 and 6).

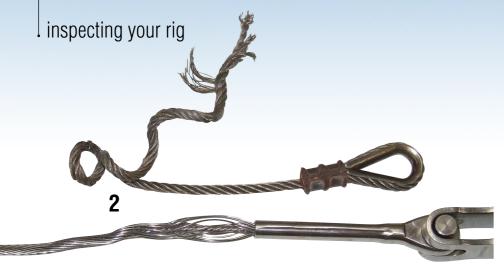
1. This photo shows the correct angle for a genoa halyard to the roller furling fitting. There is very little chance of halyard wrap in this case.

2. This photos shows the results of halyard wrap. The halyard (top) has broken and the forestay (below) is bird caged from halyard wrap. This is very common and generally caused by poor genoa halyard angles.

The top of the forestay is the most $common\,place\,for\,the\,stay\,to\,fail.\,Failures$ here are generally caused by the poor lead of the genoa halyard onto the furling swivel from the mast (halyard wrap) as well as wire fatigue due to poor toggling. The correct lead of a genoa halyard is pictured here (see photo 1) Bird-caging of the forestay is very common and is caused by the genoa halyard wrapping around the forestay and continuing to furl the sail with undue force will permanently un-lay the stay wire in the forestay and halyard and in some cases break both completely. If an abnormal restriction is felt when furling the genoa, it is best to stop and check for any problem and even dropping the genoa would be best practice in this situation. Placing the furling line on a winch and winding the sail home is bad practice as due to the power of the winch, any re-

striction will not be felt (see photo 2).
